Glasgow Inner Ring Road: Woodside 2: Bridge 11 Beam Failure 1971

JP McCafferty

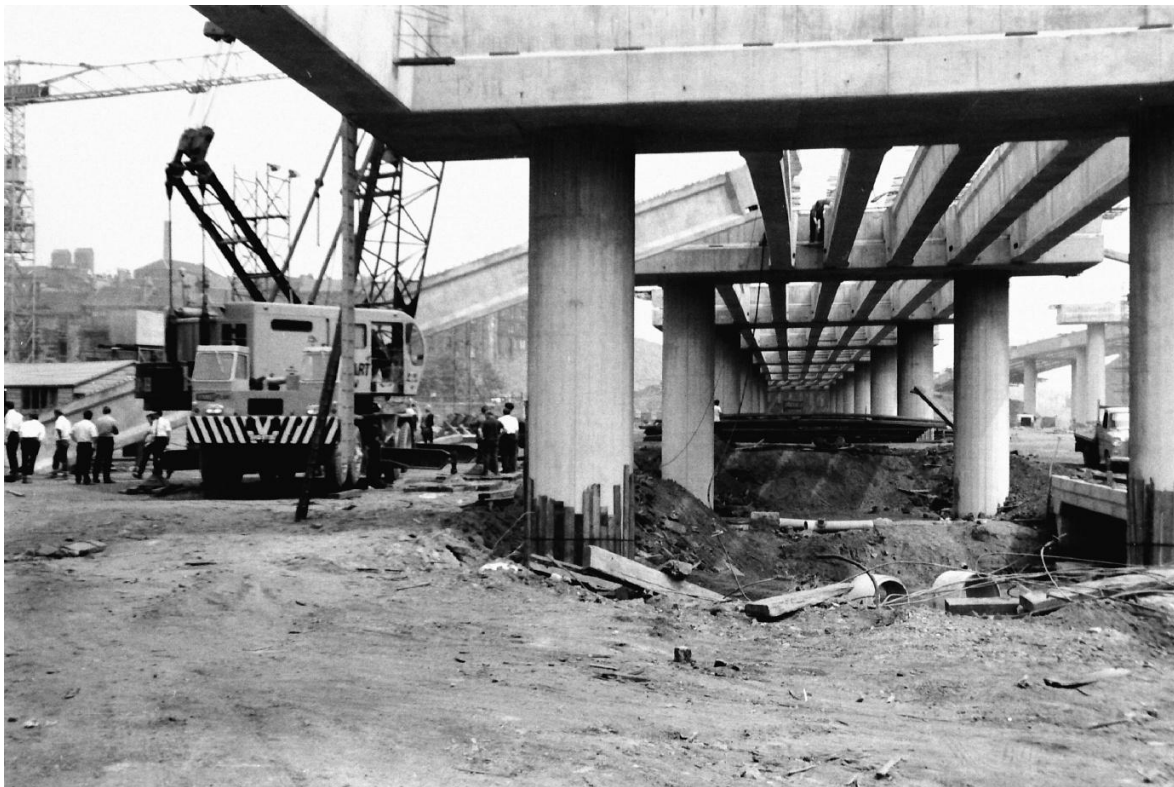
The beam, one end buried in the ground outside the Bothy, the other on the deck of Bridge 11.

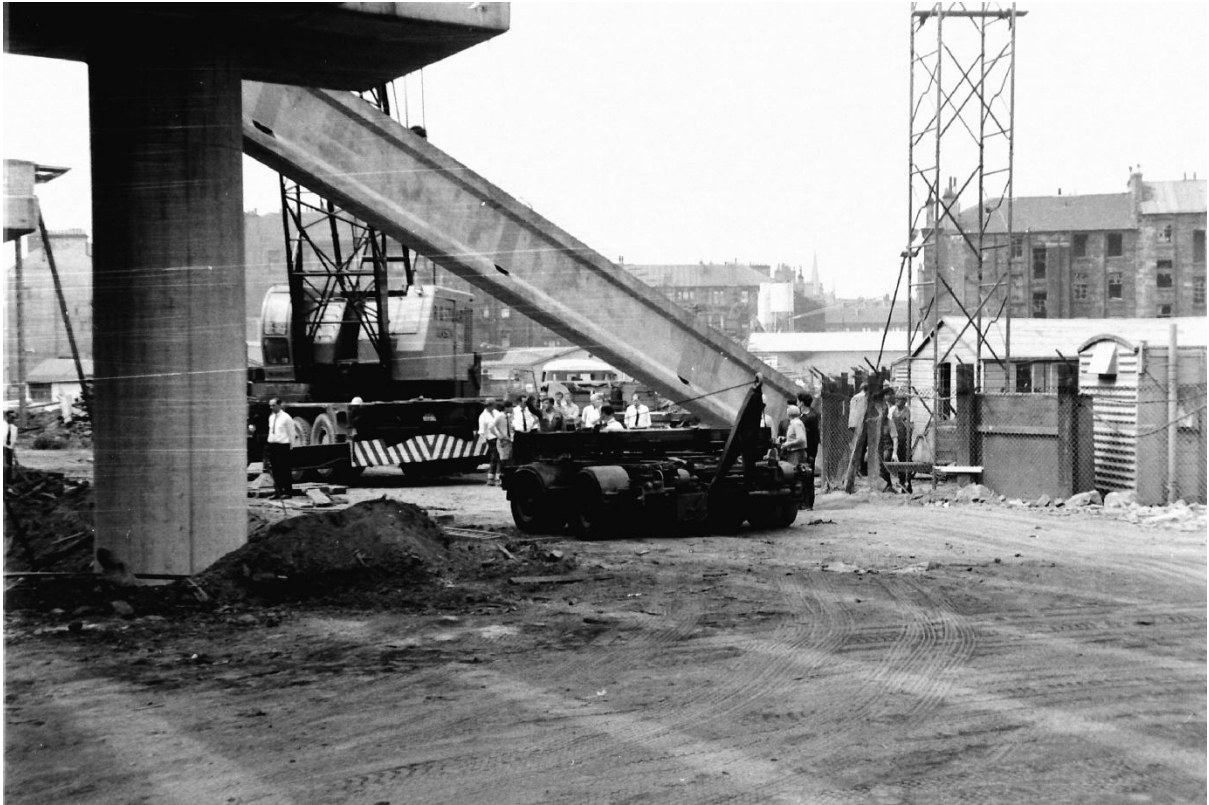
Looking south, showing the dropped beam dangerously close to the Bothy and Site Offices.

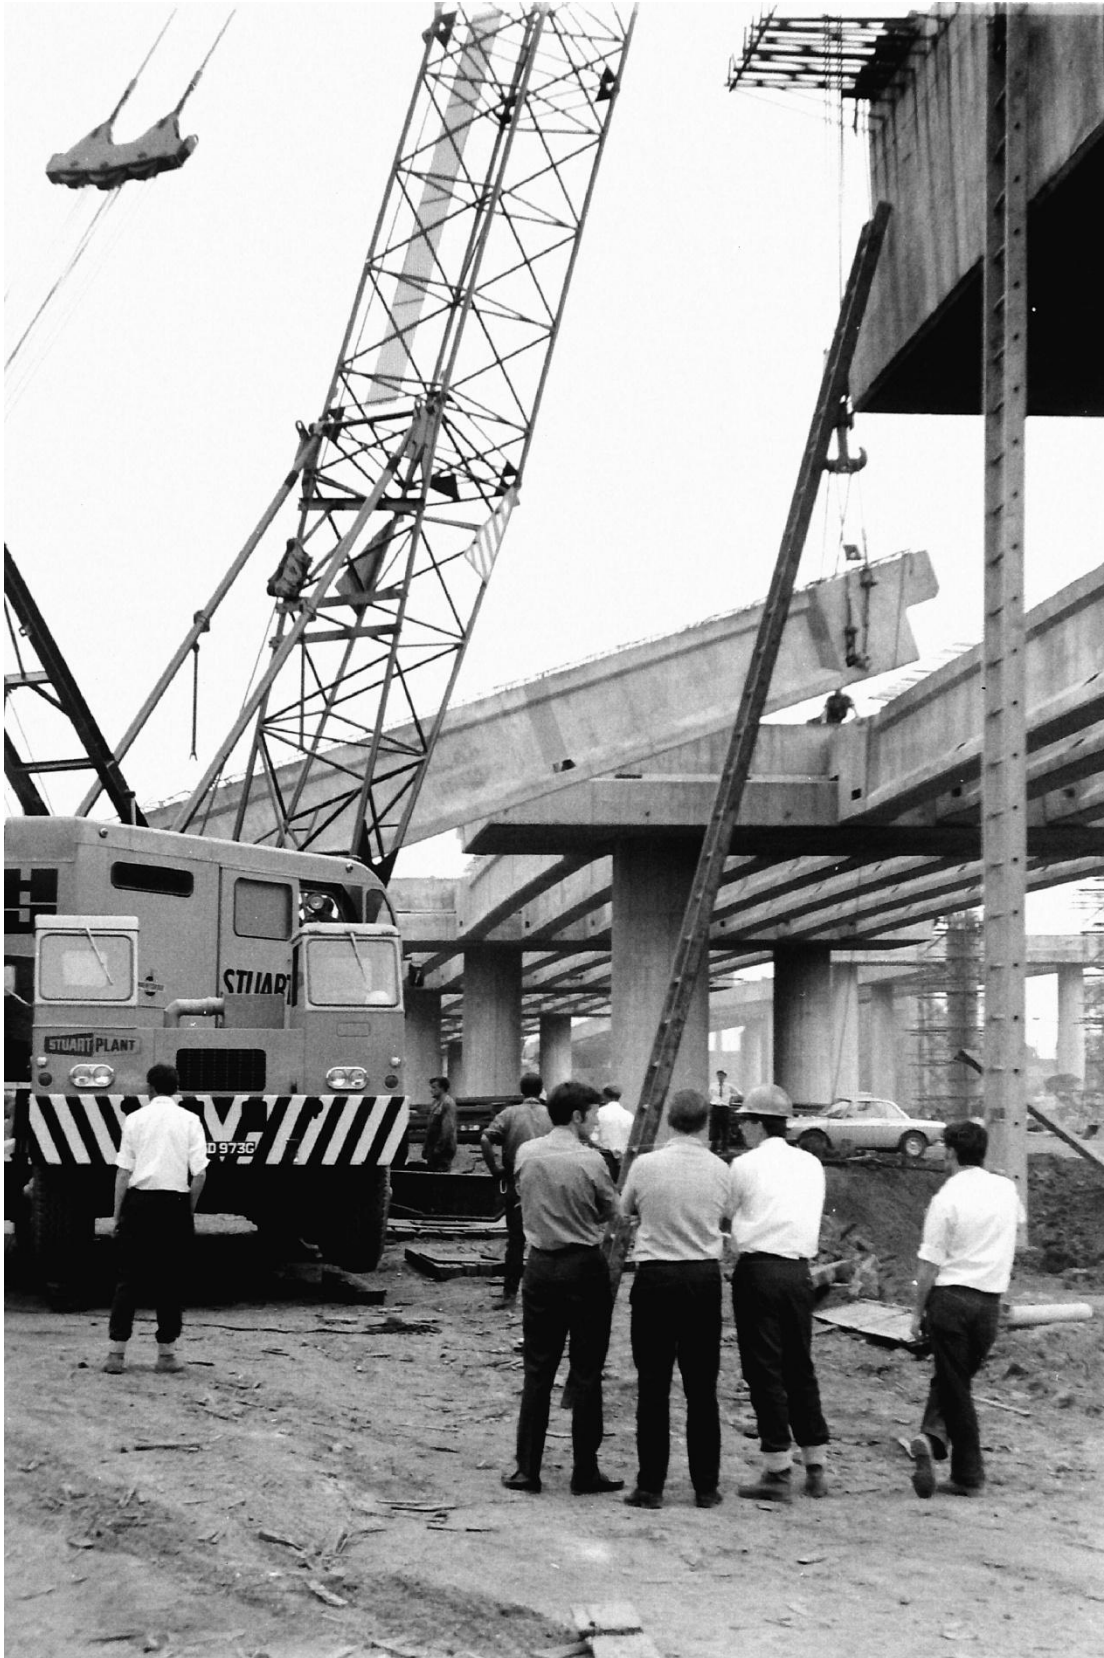
The beam being lifted, using tackle threaded through the transverse reinforcement hole. Stuart McDougall and Roger Anderson [AREs Measurement] with Bob McKittrick [ARE Roads].

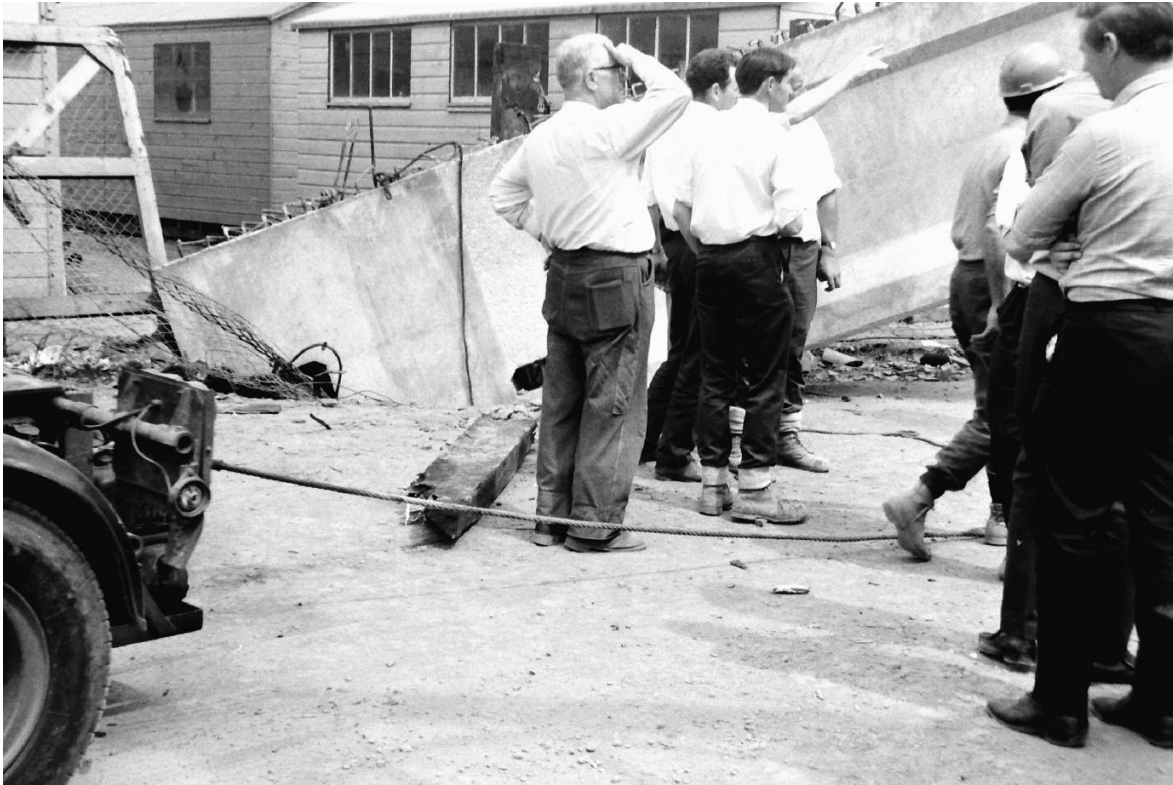
The 40t Beam buried in the ground at the Bothy and Site Offices; Stuart McDougall on the right.

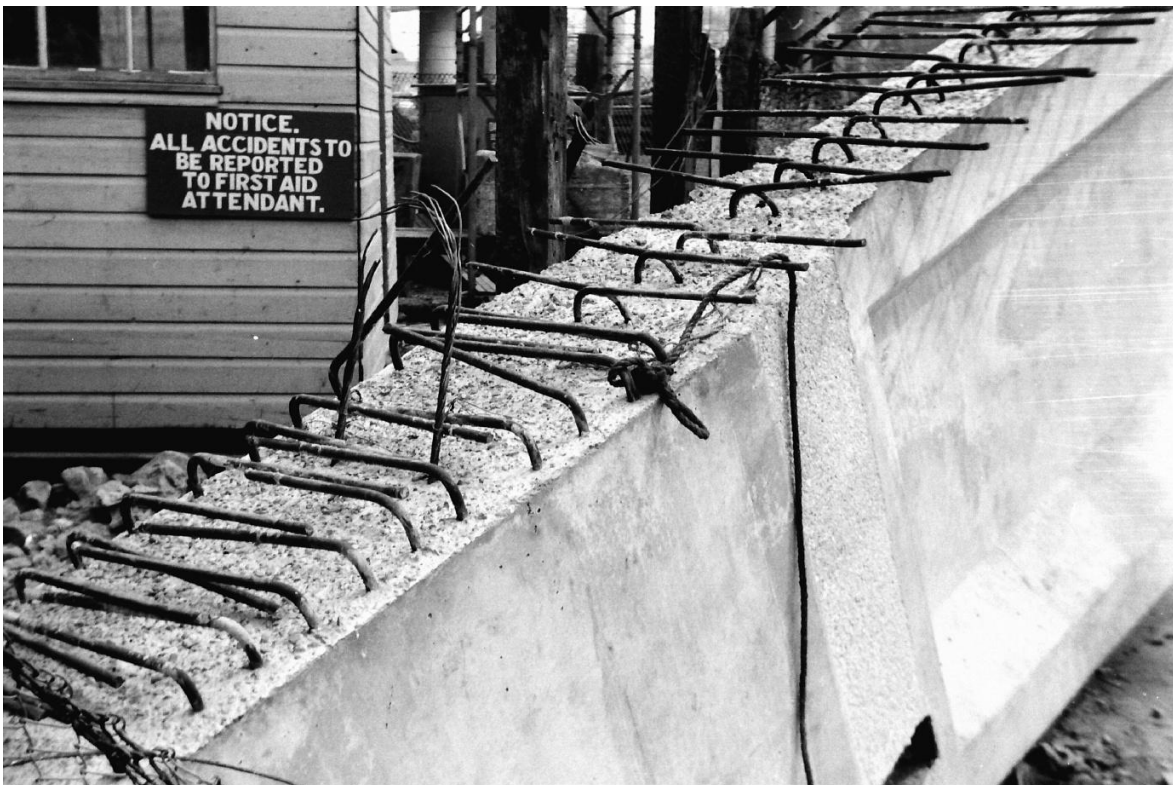
period of months with Balfour Beatty preferring a single crane lift rather than the more controllable but more expensive two-crane lift [which was used for the 80t edge beams]. In addition, permission had been sought from the Engineer for lifting hooks made of prestressing strand in the form of 'bent hairpins' which were threaded into the complex reinforcement surrounding the beam half joints, end blocks and prestressing cables and ducts. These were fixed into position aligning with the inclination of the lifting cables from the single crane. This arrangement apparently worked until the fateful day of the failure of one of the prestressing strand lifting hooks! But why did it fail when the strength of the prestressing strand provided an adequate factor of safety? Investigation quickly demonstrated that the strand [made up of several individual smaller strands had failed at the point of contact with the crane lifting hook which provided a very tight radius over which the strand 'hook' bent and kinked thus raising the stresses locally to breaking point! As I was not personally involved in checking the original proposals or in supervising the lifting operations, I am not sure that a minimum radius of say 4 times the diameter of the strand had been agreed and subsequently ignored. No matter what the originally agreed lifting arrangements were, thereafter, the lifting arrangements were re-crafted and carefully scrutinised and supervised thereafter. The beam that had been dropped was set aside and later cut into several pieces and buried in landscape 'mounding on the north side of New City Road.

The strand lifting hook showing where it failed over the small radius crane hook. Note the sign!!
