The IBM Greenock Investigations, Remedial Works and Court Case

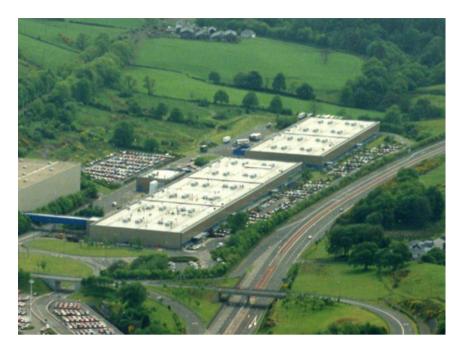
Modules 1-3 to the left and Modules 4 & 5 to the right and at a lower level

The thickest layers of imported granular fill were beneath Module 3, tapering towards Module 1. The 'motive force' of the granular fill was removed beneath these modules to reduce negative skin friction and the exposed piles cross braced to provide buckling stability.

Perhaps the most controversial decision was that, because re-driving piles beneath Modules 1, 2 and part of 3 would be impractical, it would be necessary to excavate most of the gravel infill placed beneath these modules to remove most, if not all, of the motive force causing consolidation, settlement and negative skin friction [or down-drag] on the piles supporting these modules. The floors and superstructure of Modules 1-3 were, therefore, completed and fitting-out was allowed to proceed while arrangements were made for miners to excavate the underlying granular fill leaving a giant void with stable side slopes up to ground level at the perimeter areas of the modules.

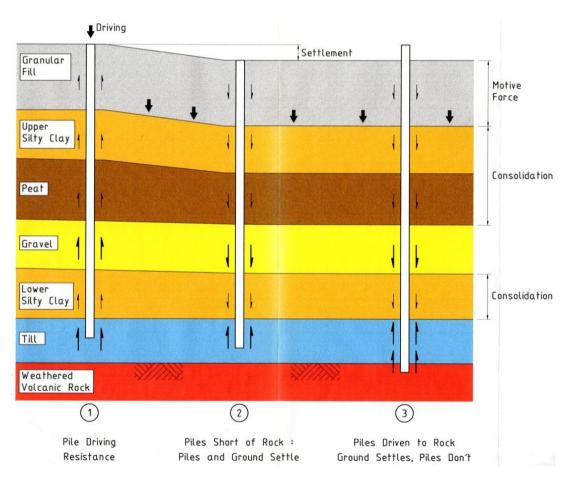
The piles had been driven to 'refusal' [using the Hilley formula as the 'mantra'] and some had been load tested! What everyone had missed was that the large thicknesses of granular fill provided the motive force for large settlements due to consolidation of the underlying upper and lower silty clays and peat!!

All ground layers, including the granular fill, provided very significant skin resistance to driving and, in the short term, to pile load testing. Furthermore, consolidation of the upper and lower silty clays and peat [which was estimated to take years to complete] immediately resulted in negative skin friction, or drag-down, on the driven piles from all the ground layers apart, perhaps, from the till resting on the rock. This resulted in overloaded piles and very large non-uniform pile and ground settlement.

Any pile that had been driven into competent rock appeared to rise above the surrounding ground level as the ground settled! Any pile driven short of competent rock was being dragged slowly downwards!

Piles, resistance to driving, down-drag, consolidation and settlement simply explained!
