Evening Meeting

An invited paper, presented and discussed at a meeting of the Institution of Structural Engineers, 11, Upper Belgrave St, London SW1, on Thursday, 18 October 2001 at 6pm.

Kingston Bridge strengthening – Phase 1

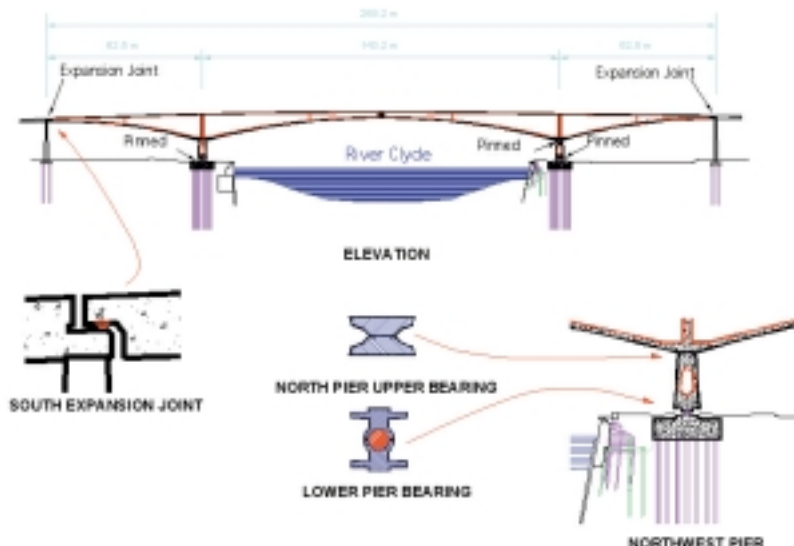
Fig 1. The articulation of the bridge as constructed

The articulation of the bridge as constructed is shown in Fig 1.

Piled foundations were constructed behind the quay walls and hammerheads were built on both sides of the river. Voided deck panels were then constructed alternatively on the landward and riverward sides and post-tensioned back to the hammer head. This continued until the landward spans were landed at half joints on the previously constructed approach structures. Construction then continued out across the river and an *in situ* concrete closing panel then joined the two halves of the bridge together. The two halves of the deck were then post-tensioned through the closing panel and the two bridges were also post-tensioned together at quarter point diaphragms. Finally, the pin bearings at the top and bot-

tom of the North Piers and at the bottom of the South Piers, which had been locked up during construction, were released.

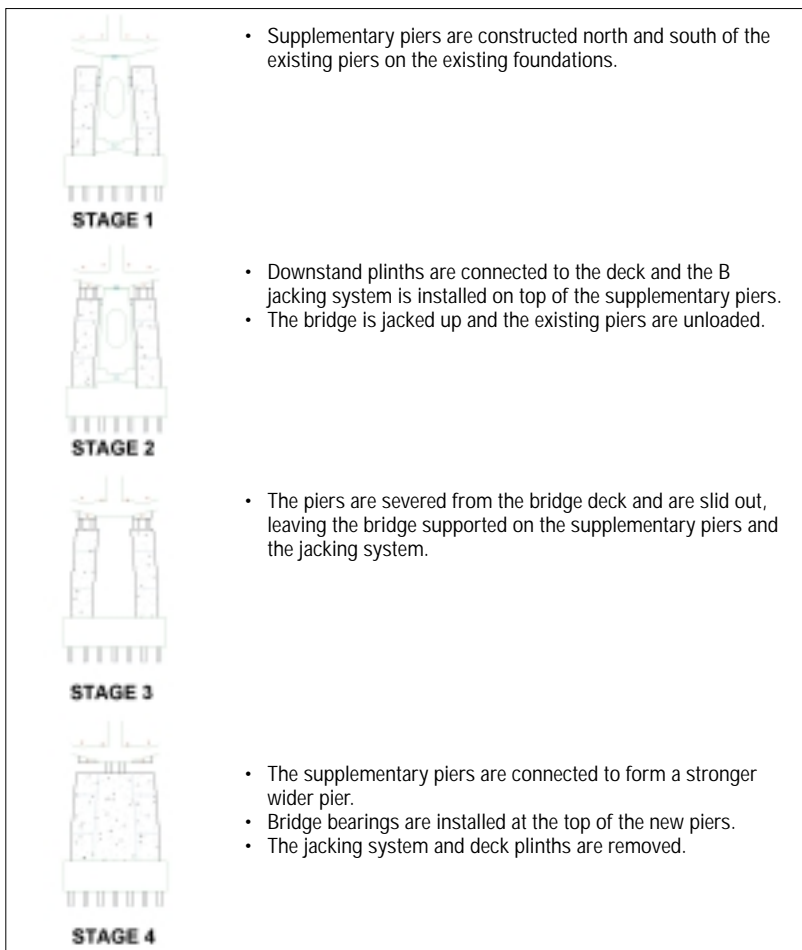
Fig. 2. Methodology for demolition and reconstruction of the bridge piers

The demolition and reconstruction of the bridge piers was carried out whilst the bridge was still open to traffic. A methodology is shown in Fig. 2.

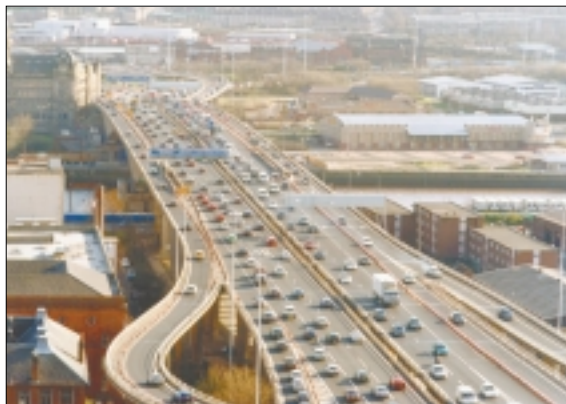
Fig. 3. Lane restrictions and concrete blocks during the works

Until the strengthening works could be carried out, interim measures had to be implemented to prevent the bridge from becoming overloaded. This was achieved by a combination of reducing the number of running lanes on each carriageway

on the bridge from five to four, weight restricting one of the lanes to 7.5t, and placing concrete blocks at the end of the bridge to increase end bearing reaction.

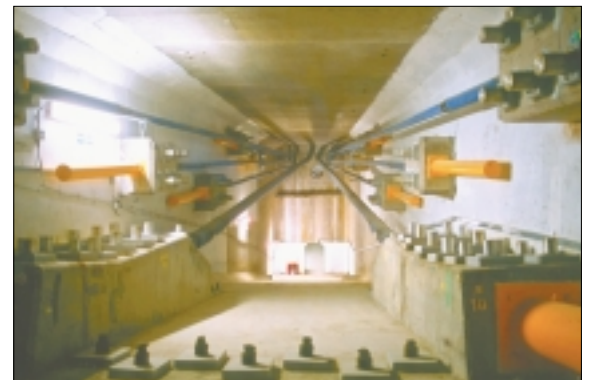
Fig. 4. External prestressing tendons retrofitted inside the existing bridge deck voids

These tendons, which were external to the concrete section but located inside the deck void (Fig 4), were then stressed incrementally from alternative ends of the bridge, using three or four single strand jacks. A strict simultaneous stressing sequence ensured an even rate of stress application and also ensured that no torsions were induced in the webs.

Approximately 90MN of additional prestress was induced into each deck. To ensure strand replaceability, the strands, which are greased sheath monostrand, were kept parallel along the whole length of the tendon and grouted after stressing. Strand replaceability trials were carried out after grouting to demonstrate that replaceability had been achieved.

- The installation of concrete anchor blocks in the end spans connected to the existing webs and bottom slab by post-tensioning bars.
- The installation of deviators at existing deck diaphragms.
- Threading post-tensioning cables from the south side of the bridge to create 20 No. 12 strand web tendons and six No. 48 strand bottom slab tendons per bridge.

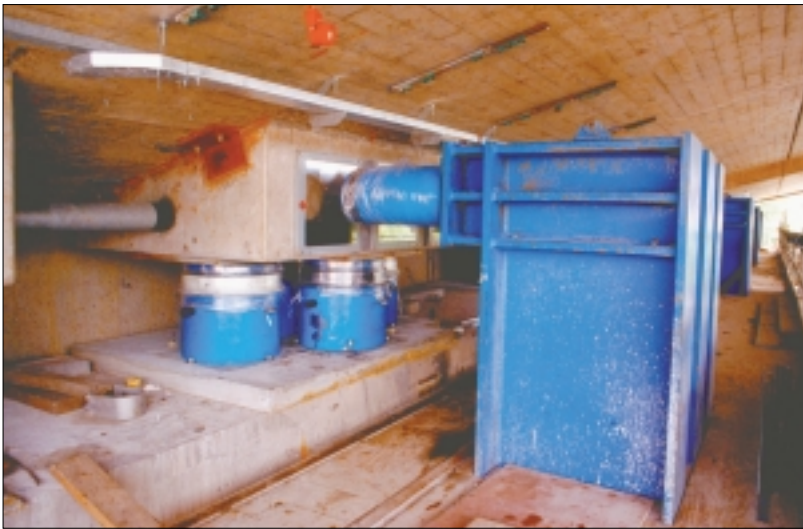
Fig 5. Hydraulic jacking systems B and C

The B system was used to lift the bridge and support it on hydraulics for a period of 10 months. It comprised a system of 128 1000t jacks which were supported on new columns and reacted against downstand plinths connected to the deck. The B System consisted of 32 active jacks per pier which were capable of lifting the bridge but because the bridge would be supported on hydraulics for such a long time, this was backed up by 32 reserve jacks in case the active system failed. Each jack was equipped with a locking collar as an ultimate rigid support in case of failure of both the active and reserve systems. All B jacks were capped by sliding and rotating devices to permit horizontal and rotational movement.

The A, C and D systems were horizontal systems that provided the longitudinal and transverse fixity of the bridge deck when it was supported by the B system. The C system was also used to move the bridge deck to the south to relieve the load on the north approaches and to partially redress the excess travel on the south bearings (Fig 5).

The jacking system which was used to lift the bridge and unload the existing substructure comprised of four separate jacking systems, A, B, C and D. Each was operated and

monitored by a computerised control system.

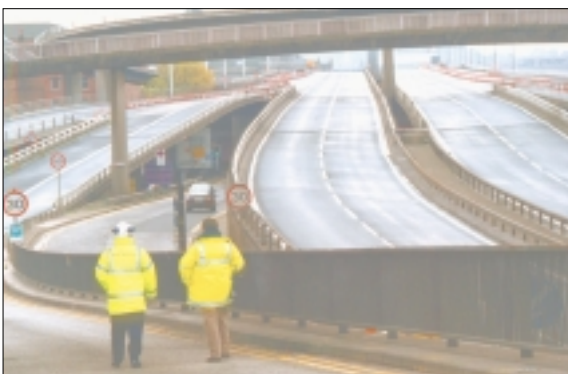
Fig 6. The motorway was totally closed during jacking operations

During a 17h total closure of the motorway, which took place in October 1999, the 52 000t bridge deck was lifted 20mm. One week later during another overnight closure the deck was pushed south 30mm (Fig 6).

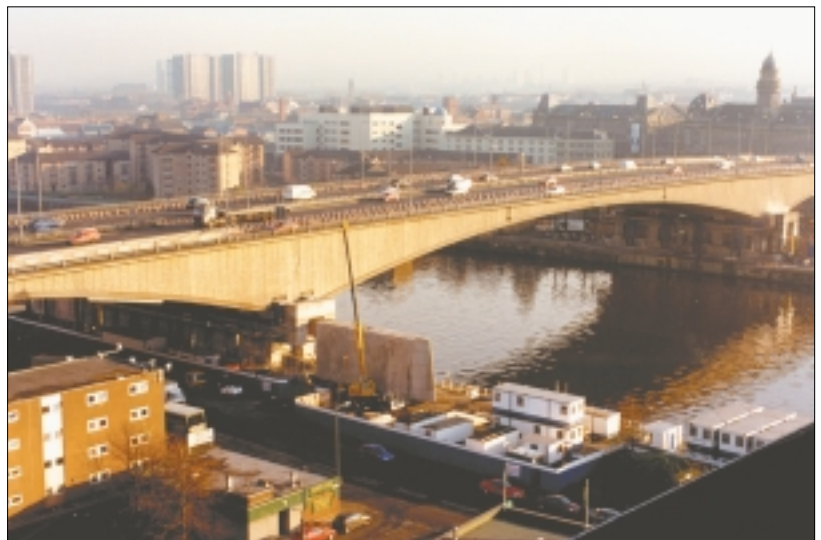
Fig 7. Existing pier slid out from below bridge

Once the pier had been severed from the bridge deck the existing pier had to be slid out from below the bridge and leave it supported by the supplementary piers and the jacking system (Fig 7). This was envisaged at the tender stage as being a series of overnight operations carried out with the

For each pier, 12 plinths were constructed in the bearing chamber below the pier and another 12 were constructed adjacent to the pier. Flat jacks contained within shear boxes with sliding plates on the top were then inflated to support the weight of the pier.

Prestressing cables had been passed under the pier and connected to steel beams at the far end. These cables were tensioned and at a load of around 2t the 900t pier began to slide. Once the pier had slid to a position where it was supported on 10 of the original plinths and was positioned over two of the adjacent plinths, the flat jacks on the new plinths were inflated to restore the number of support points to 12.

This process was repeated until the pier had moved out on to the plinths adjacent to the bridge. The piers were then secured and demolished using hydraulic breakers.

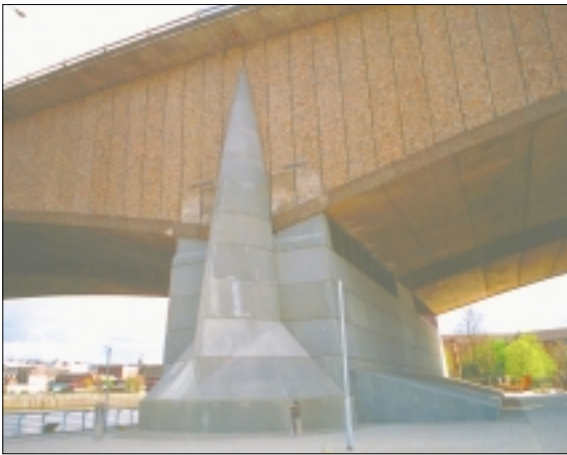
Fig 8. After installing the new bridge bearings

A requirement of the design was that no riverward load should be applied by the deck to the foundations. This was achieved by having a system of pot bearings at the South Pier react against a system of elastomeric bearings at the North Pier. After installation the north elastomeric bearings were pre-sheared such that, even at low temperatures, the horizontal bearing reaction is always landward. Extremely onerous differential displacement criteria had been set for the jacking period and to ensure that this was maintained

during the lowering of the bridge onto the new piers, the bearings were preloaded by a series of flat jacks that were inflated during a bridge closure using grout. The bridge remained closed until the grout had achieved its initial set and the deck was then jacked clear of the bearings and the bridge reopened. One week later, once the bearings had been fully grouted and the grout had achieved full strength, the bridge was finally lowered under a short term closure on to the pre-set bearings.
