Civil Engineering 150 February 2002
Pages 22–28 Paper 12672

Float viaduct—a high-speed rail bridge replacement

M. Hackney, A. Stocks and C. Dodgson

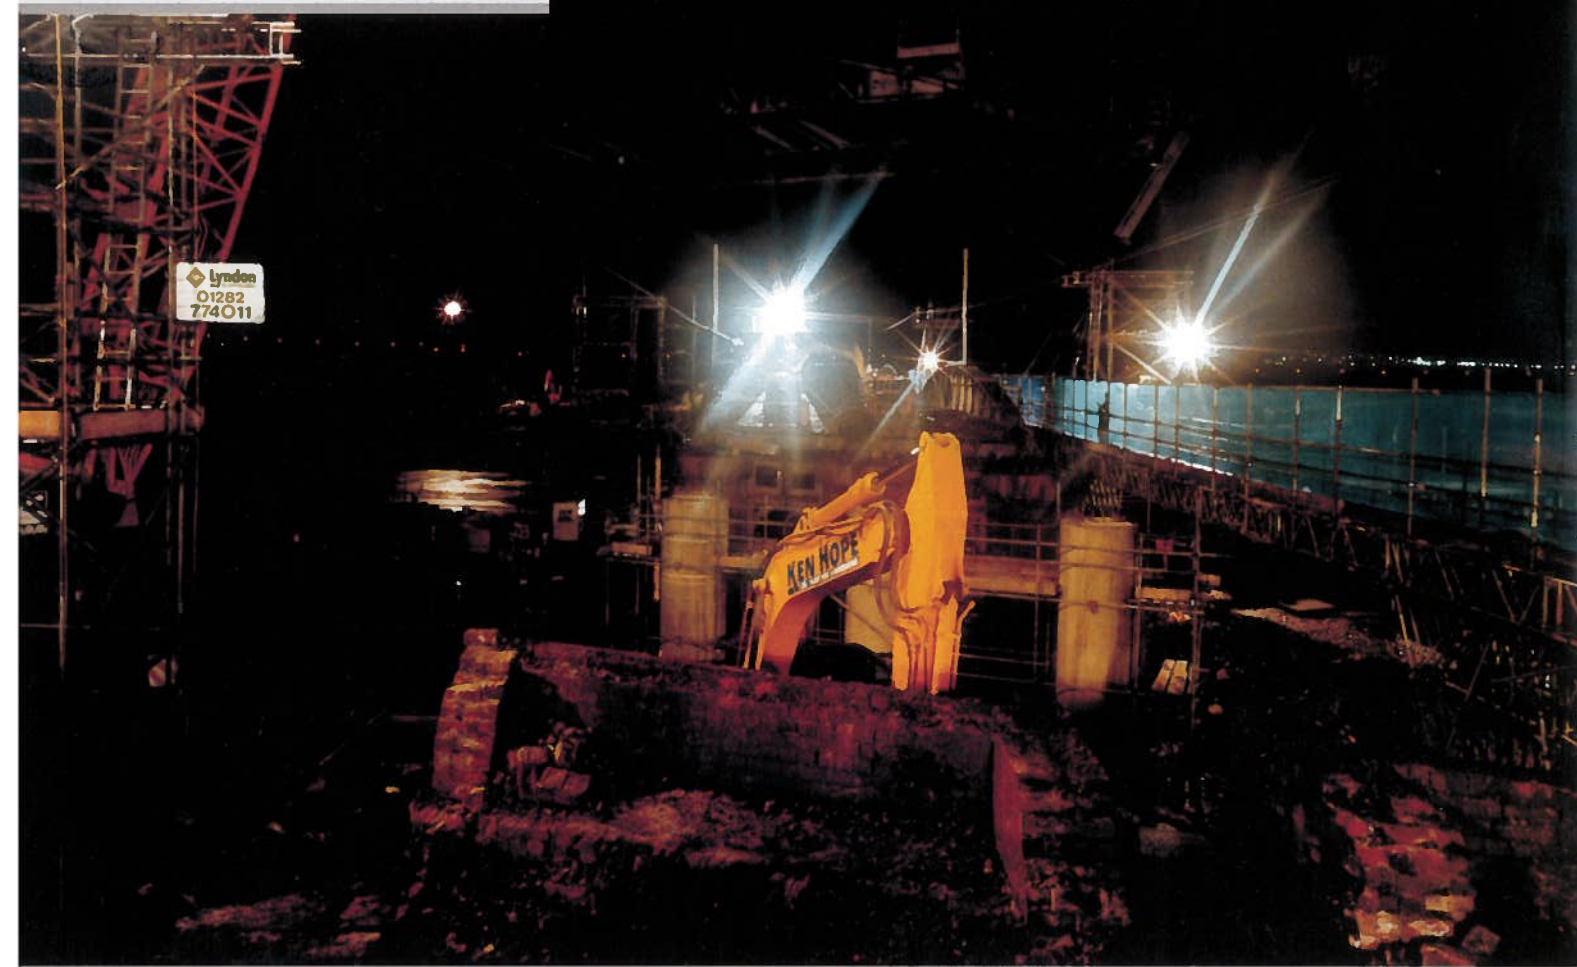
Fig. 6. The first span of the existing bridge deck being lifted out by a 900 t mobile crane during the five-day possession

Initially, the crane was unable to lift the span clear of the pier support. The bottom flange of each girder was then cut locally to allow the span to be lifted clear (Fig. 6). Subsequent inspection of the area, which had previously been inaccessible, revealed that the problem was caused by steel wedges down the sides of the bearing shoes causing ‘lock-up’. The remaining spans presented no further unexpected problems and the delay to the programme was soon recovered. All spans were removed to a designated demolition area where hydraulic shears quickly dis-

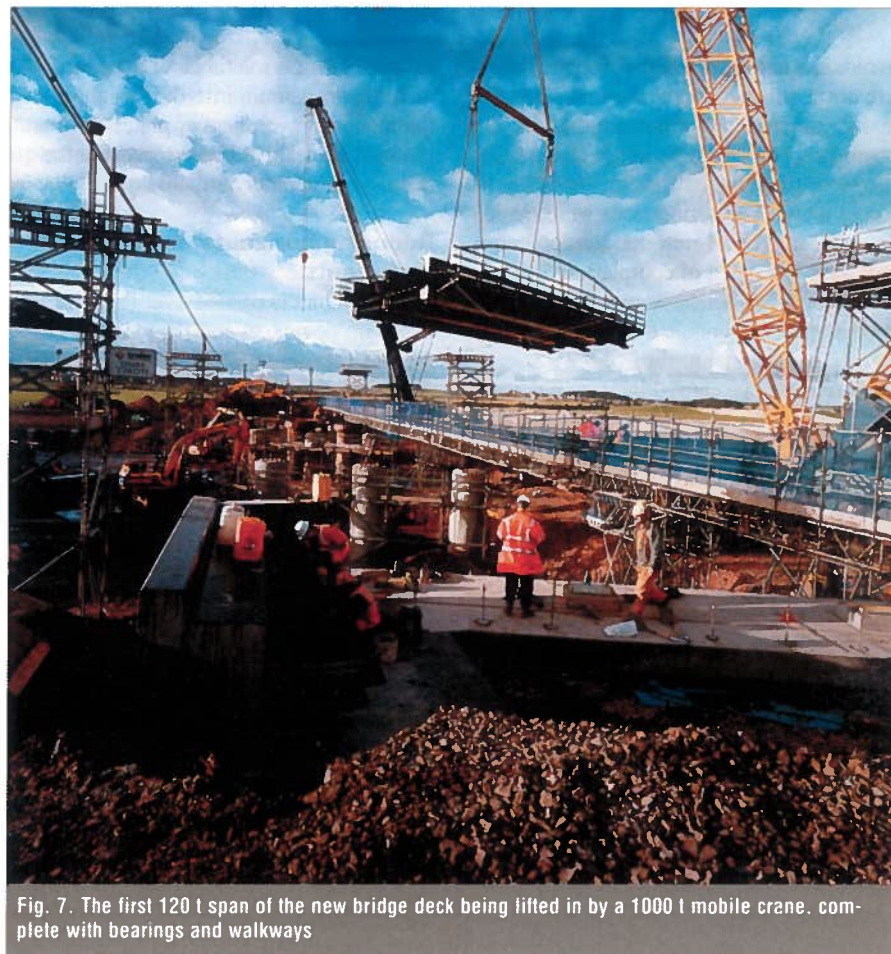
Fig. 7. The first 120 t span of the new bridge deck being lifted in by a 1000 t mobile crane, complete with bearings and walkways

The first new deck section was then erected onto the new substructure using a 1000 t mobile crane (Fig. 7). When the span was positioned correctly, the bearing bottom spreader plate at each of the supports was welded to a steel bearing plate, which had been previously bolted to the substructures. This procedure was repeated for the remaining spans, each deck section being connected to the preceding one with bolted splices between the adjacent girders and deck plate.

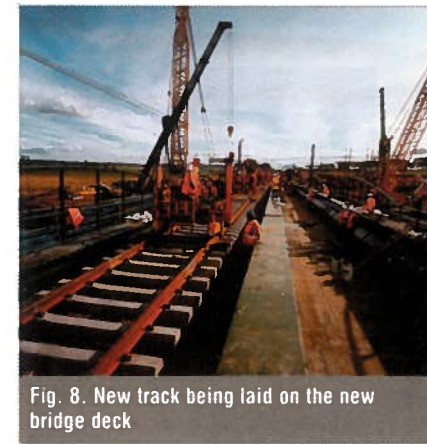
Fig. 8. New track being laid on the new bridge deck

Finally, the deck joints, new ballast and track were installed (Fig. 8) and the overhead line equipment was connected to new masts on the deck. The structure was completed and the line was ready for reopening well within the five-day possession (Fig. 9).
