GIRR Woodside 2: Precast Beams and Half Joint Tests

A History of Scott Wilson Scotland: Doc 13 Appx 1: GIRR Woodside 2: Beams & Half Joint Tests
JP McCafferty

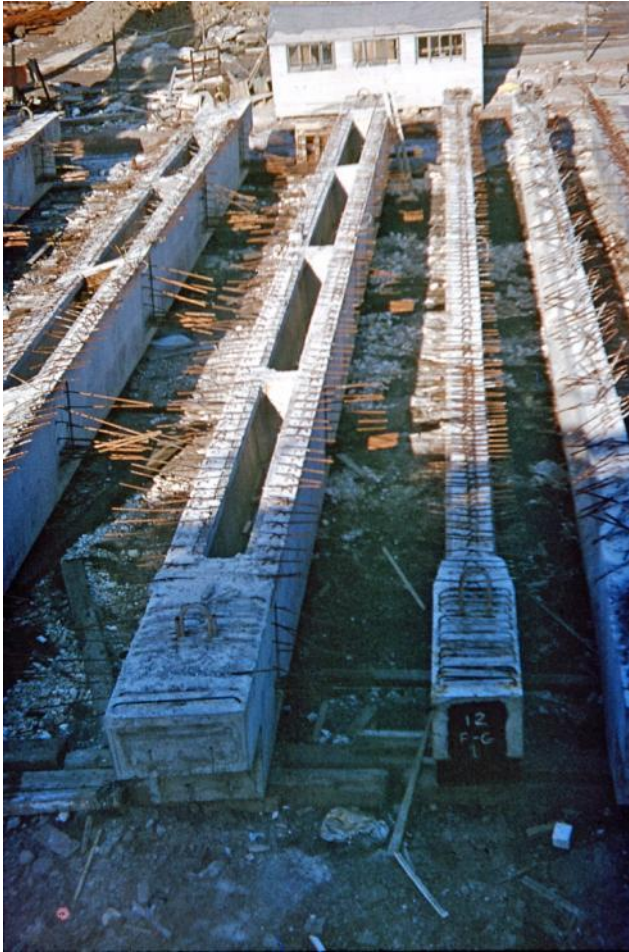
The photograph [left] shows a skewed edge beam, a standard edge beam, a standard internal beam and a skewed internal beam 'curing' and awaiting installation.

The edge beams weighed approx 80t and the internal beams approx 40t.

Beam length was approx 85ft [26m] and depth approx 5.25ft [1.6m].

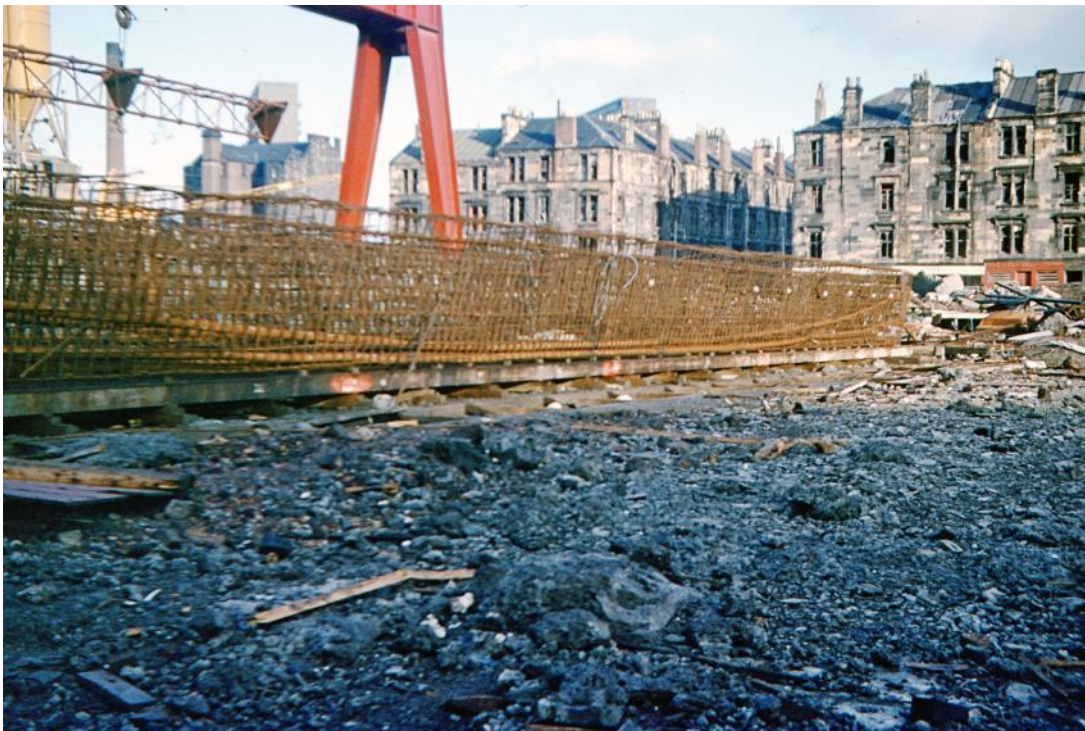
The photograph below shows an edge beam with reinforcement, prestressing tendons and ducts in position awaiting steel shuttering prior to placing concrete.

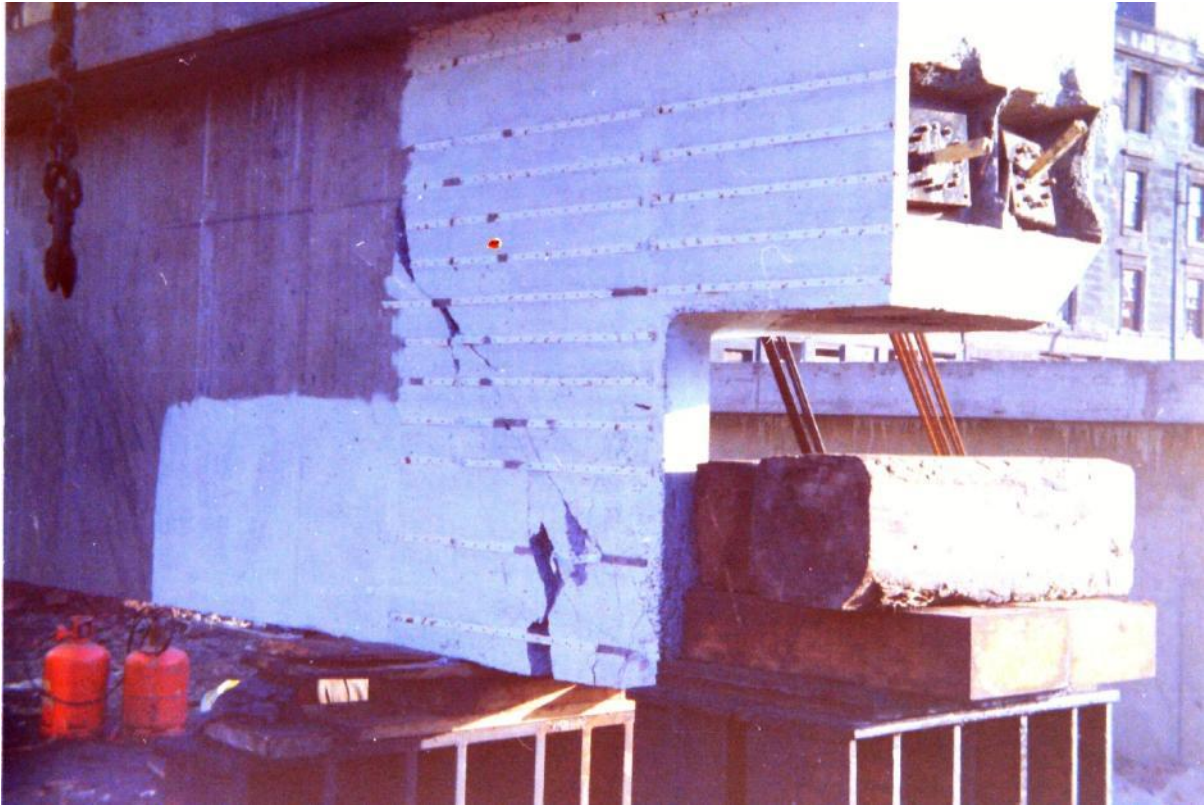
A skewed edge beam half joint on completion of test with jack removed and supported from the underlying ground. Note the steel cable rock anchors, the steel jack support block [resting on the underlying rc pile], the DEMEC strain gauge points and, in this case, the unusual main crack running from the bottom of the beam rather than from the 'root' of the half joint.

Short, lengths of test beams, including sections of top slab 'deck', were constructed with different half joint designs at both ends. A bored, cast-in-place rc pile was driven to rockhead and steel cable rock anchors were constructed adjacent. A pneumatic 'jack' positioned on top of the rc pile provided the upward thrust to the half joints and this was restrained by the rock anchors located an appropriate distance beyond the half joint. The ends of the test beams were painted white and DEMEC strain gauges were used to determine the strains at each increment of test load.

The DEMEC strain gauge consists of a dial gauge attached to an Invar bar. A fixed conical point is mounted at one end of the bar and a moving conical point is mounted on a knife edge pivot at the opposite end. The pivoting movement of this second conical point is measured by the dial gauge. Pre-drilled stainless-steel discs were attached to the test beams using an epoxy adhesive. Following each loading increment, the conical points were inserted into the holes of the discs and the reading on the dial gauge noted. In this way, strain changes in the test beams were converted to readings on the dial gauge. Cracks, which developed as the test loads reached their upper limits, were marked on the white paint using indelible marker pens and photographs taken. The information was then sent back to the Bridges team at Park Circus for analysis and finalisation of the designs.
